# Debris/Ice/TPS Assessment And Photographic Analysis For Shuttle Mission STS-41

(NASA-TM-103814) DEBRIS/ICE/TPS ASSESSMENT  
AND PHOTOGRAPHIC ANALYSIS FOR SHUTTLE  
MISSION STS-41 (NASA) 151 p CSCL 22B

DEBRIS/ICE/TPS ASSESSMENT  
AND  
PHOTOGRAPHIC ANALYSIS  
OF  
SHUTTLE MISSION STS-41

October 6, 1990

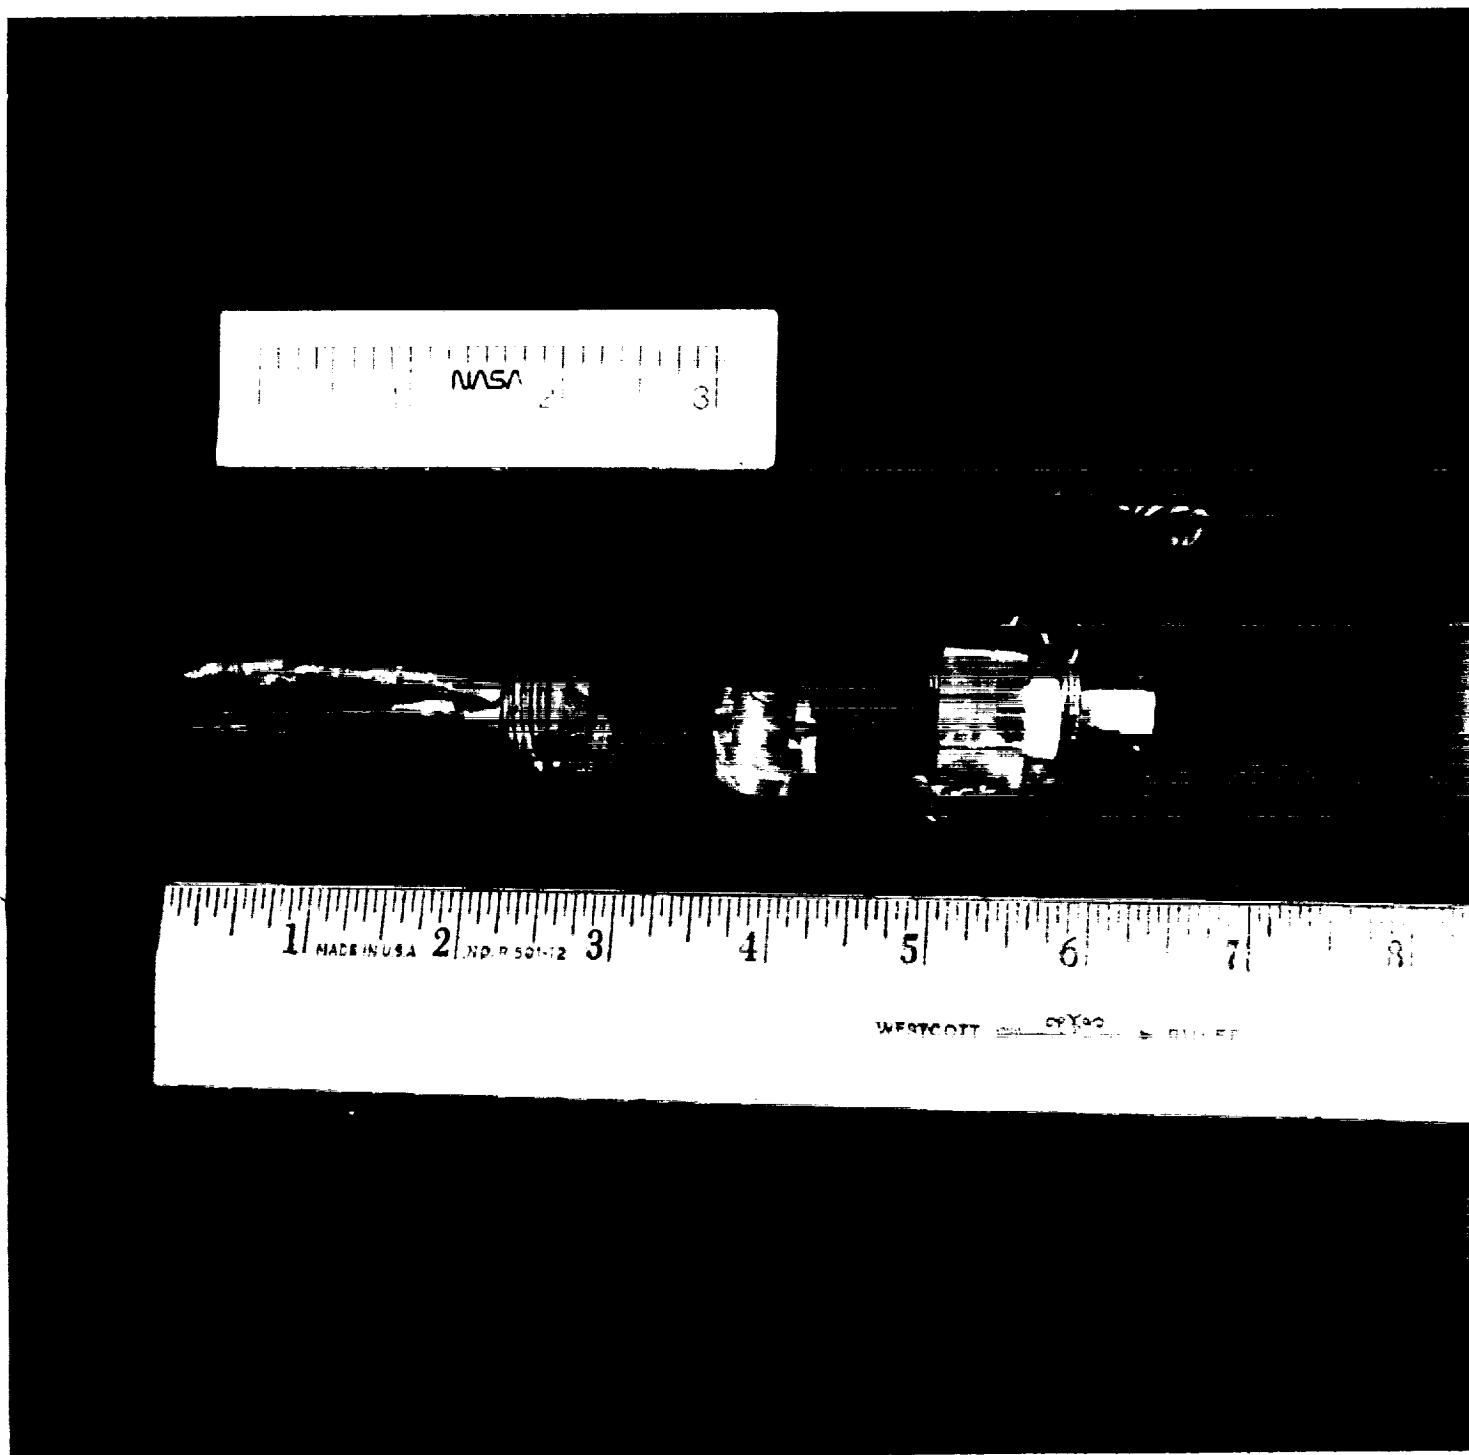
Three pieces of spent ordnance (detonator, booster fragment,  
connector piece) lay on the runway below the EO-2 attach point

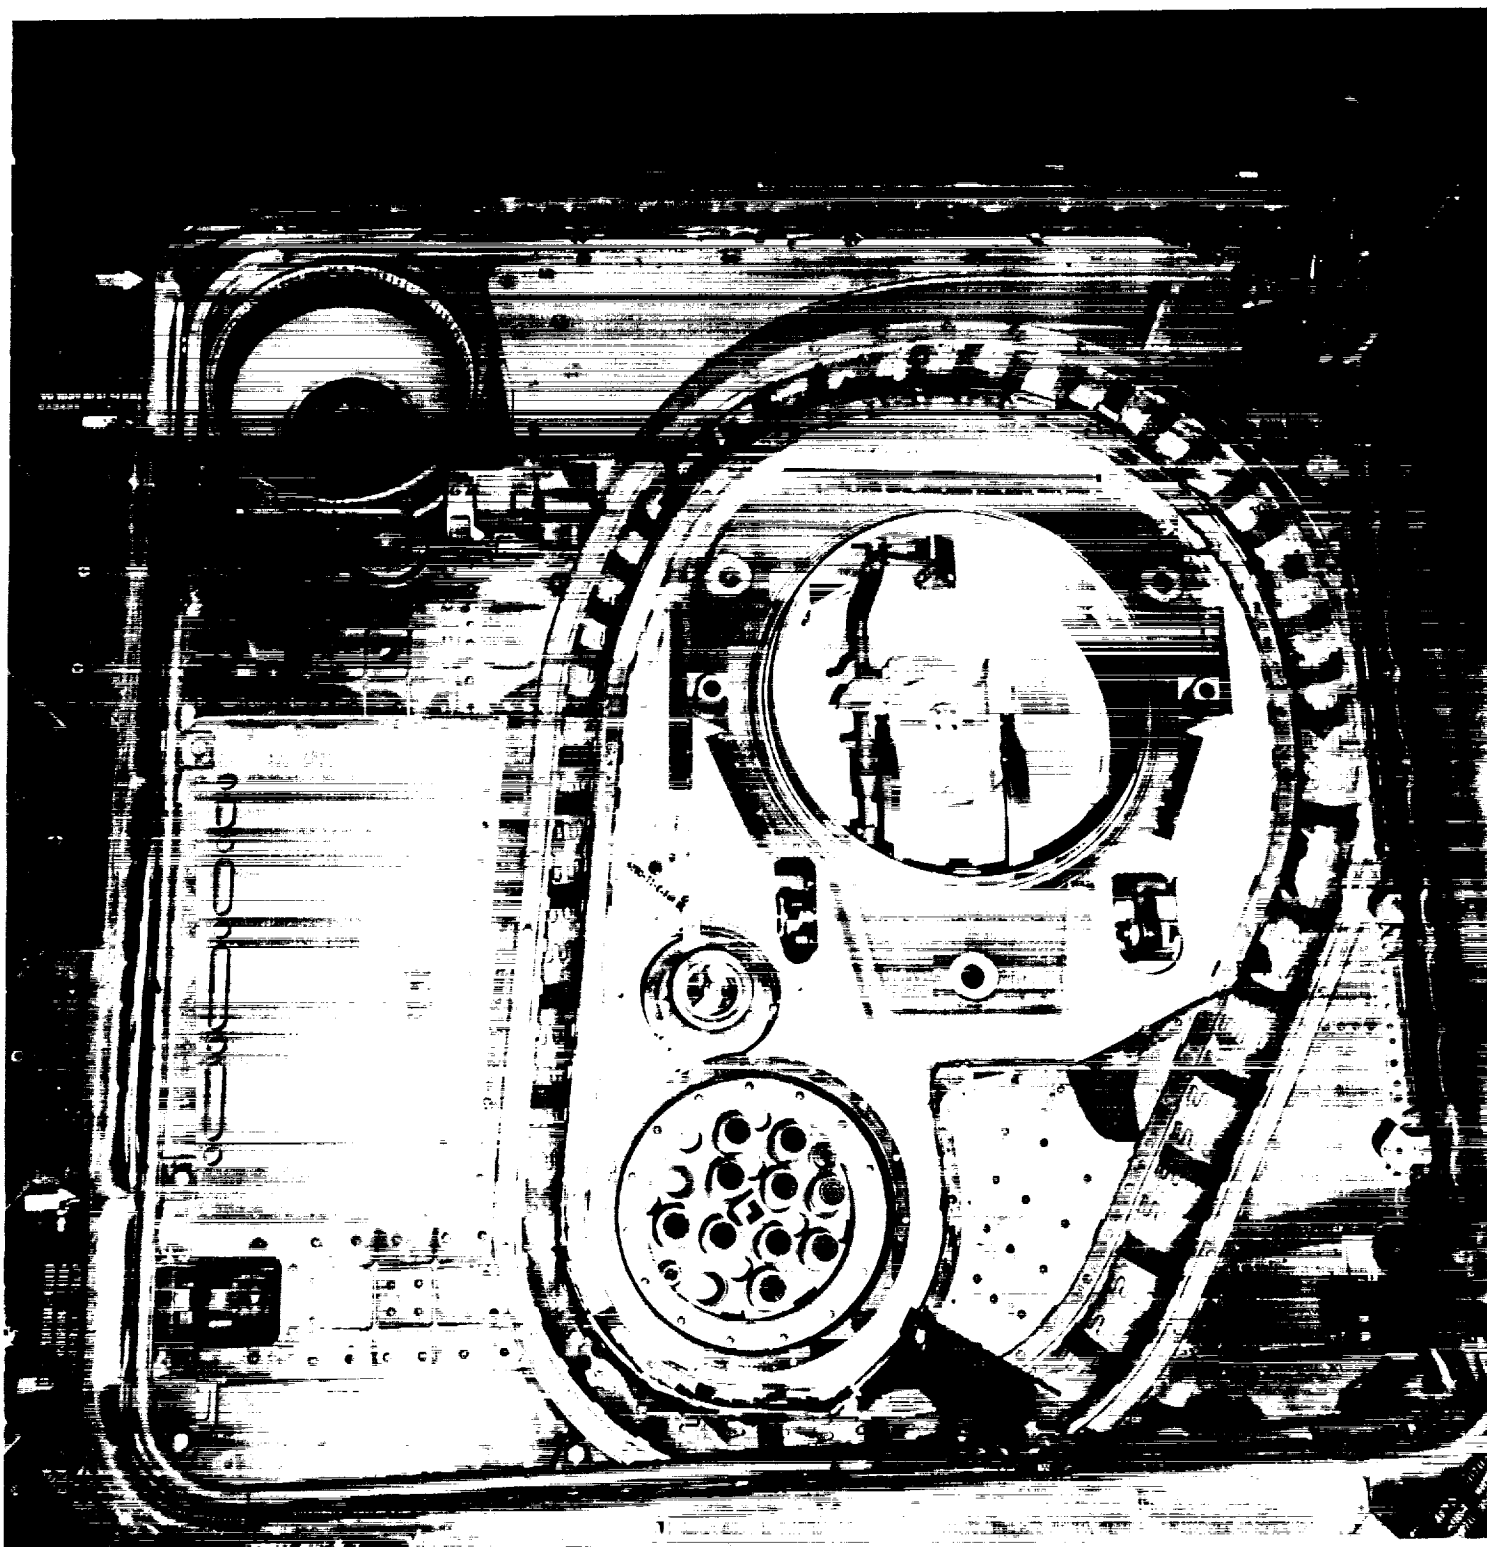
View of ET/ORB L02 umbilical
